Carved in Stone

A Texas flood's aftermath reveals an unprecedented view of geologic faults

By David A. Ferrill, Ph.D. and Alan P. Morris, Ph.D.

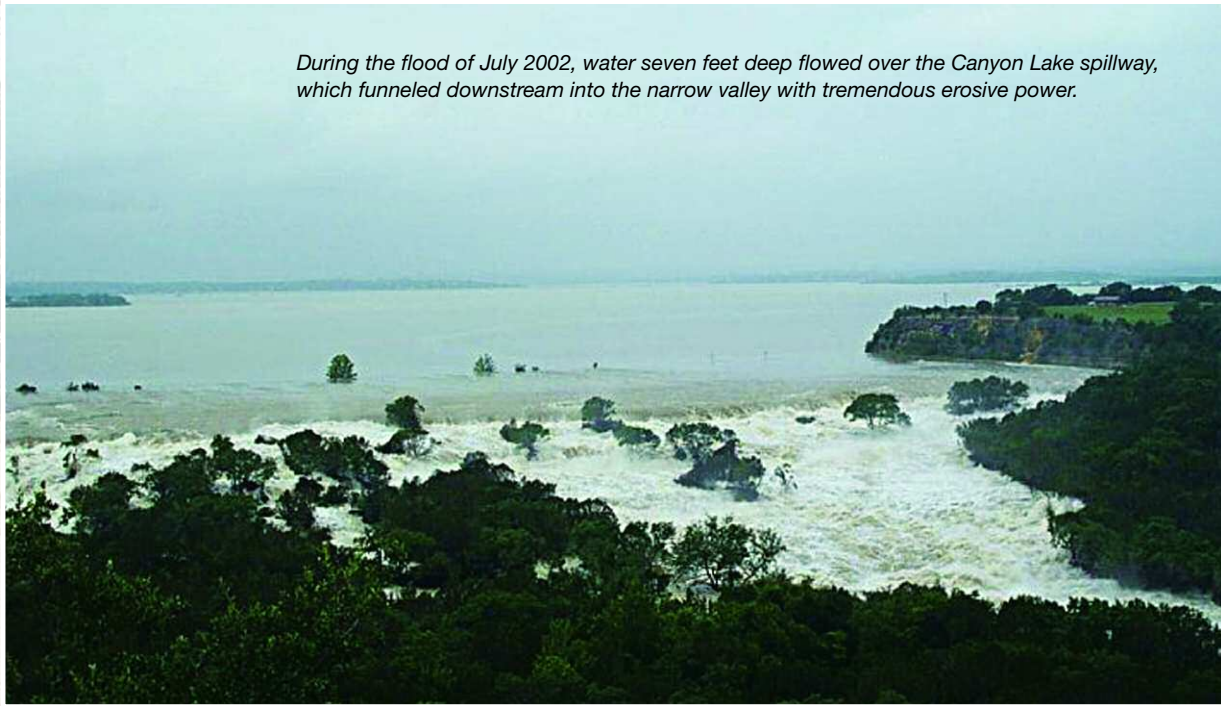
Photo courtesy Comal County Engineer's Office

During the flood of July 2002, water seven feet deep flowed over the Canyon Lake spillway, which funneled downstream into the narrow valley with tremendous erosive power.

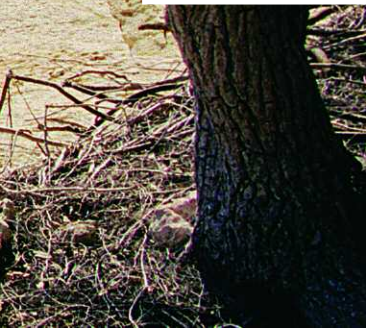
The flood of the Canyon Lake spillway scoured through the valley floor, incising a deep gorge in the Glen Rose Formation bedrock, leaving hints of the former valley floor with exposed root mats on the edges of the gorge. The locally deepest incision occurred where faulted and fractured rock adjacent to the Hidden Valley fault was stripped out along the valley floor.

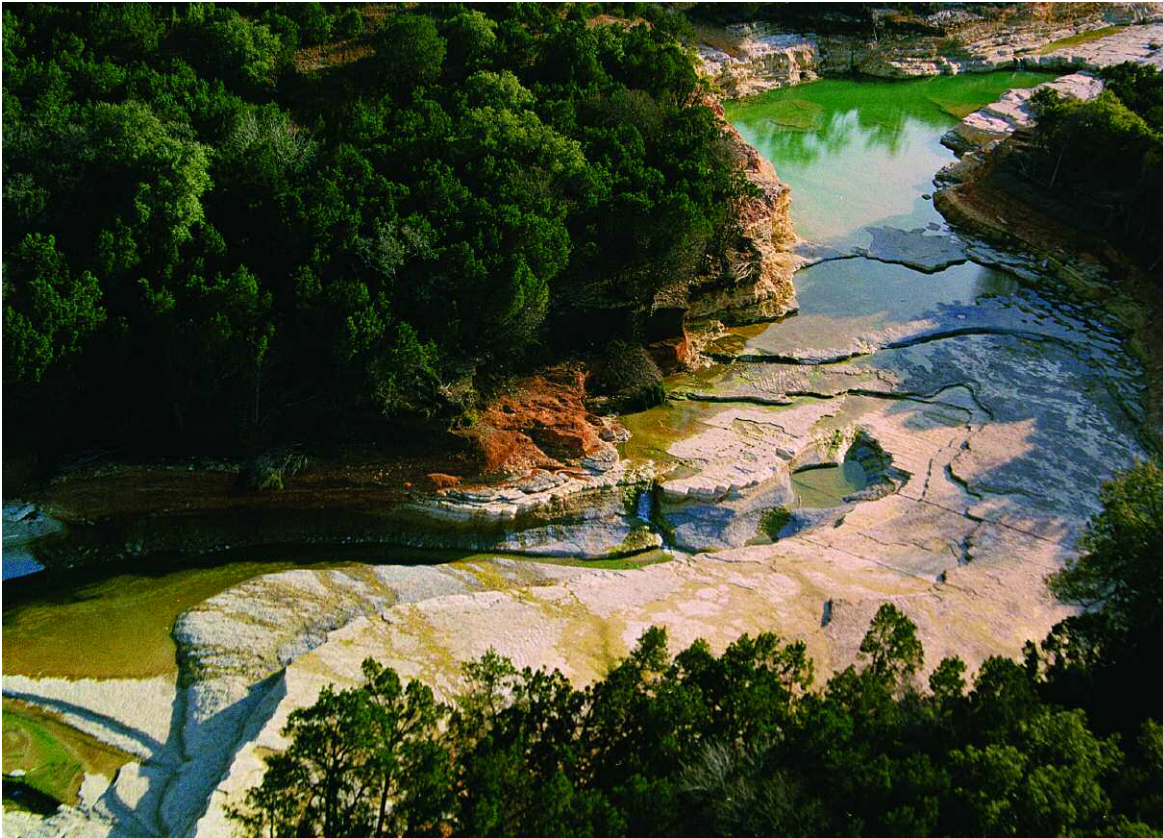
A large surface water pond, partially fed by a spring discharging from the Hidden Valley fault, rests on the up-thrown side of the Hidden Valley fault and the principal fault displacement zone itself. The pond is formed where layers that dip gently toward the fault were stripped off by erosion during the flood, leaving a depression now filled by the pond.

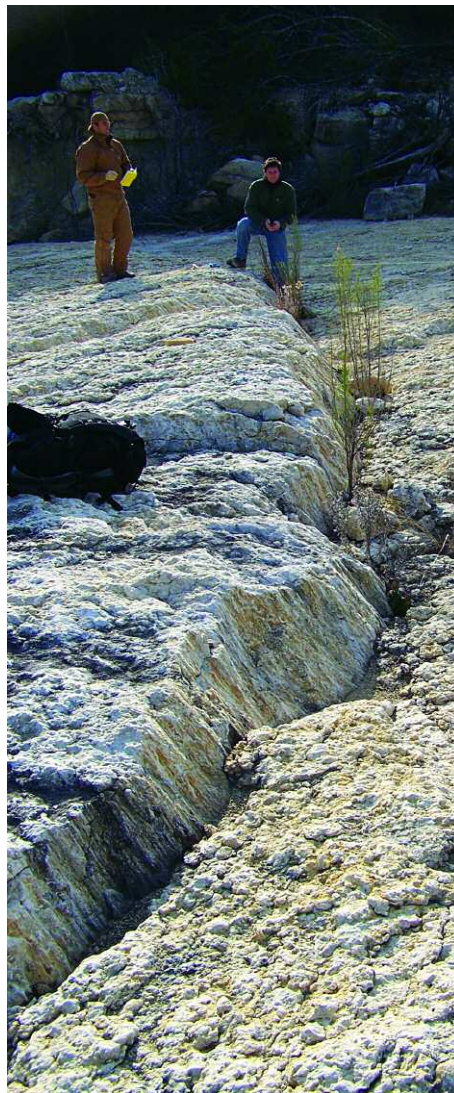
Small displacement (“subseismic scale”) normal faults are abundant at Canyon Lake Gorge and, like this one, most commonly occur near the Hidden Valley fault. These small fault surfaces are marked by slickenlines formed during fault slip, providing clear indicators for the direction of slip on the fault.

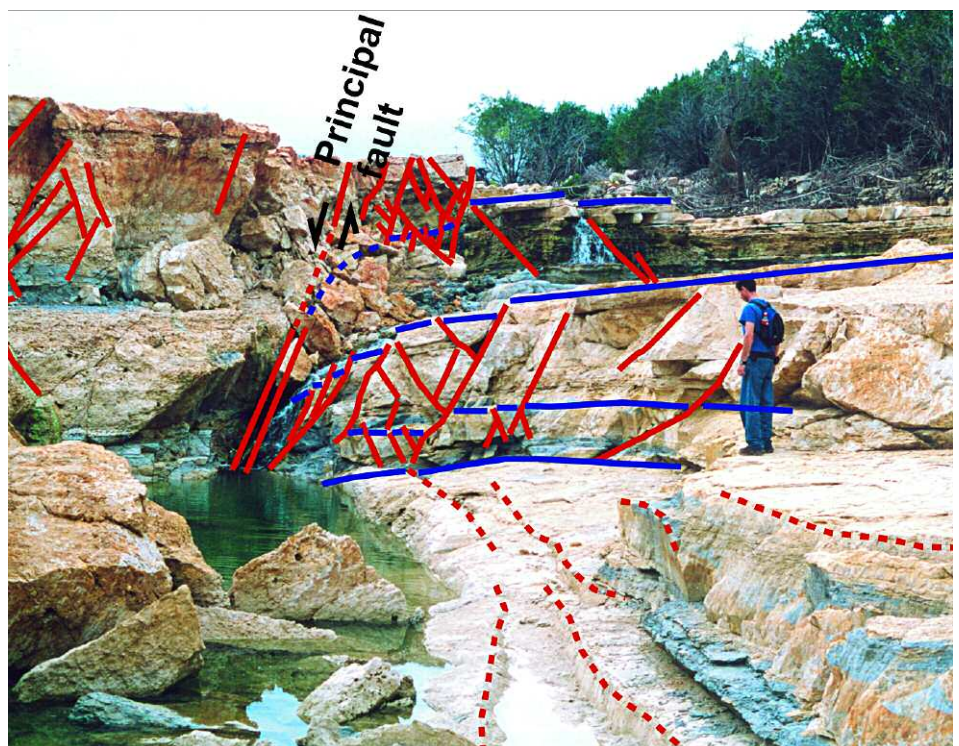
The Hidden Valley fault dips steeply to the south-southeast. Layers on the up-thrown side of the fault are tilted gently to steeply in the same direction as the fault. Layers on the down-thrown side of the fault tend to be horizontal or dipping gently in the same direction as the fault.

Small displacement faults are abundant near the principal fault surface, and dip both in the same direction as, and opposite to, the principal fault.
